# Deterioration of Bond Between Repair Material and Concrete Due to Thermal Incompatibility

A. Al-Ostaz

Department of Civil Engineering - University of Mississippi

## Case Studies of Failures in Repair Techniques Used by MDOT in Mississippi

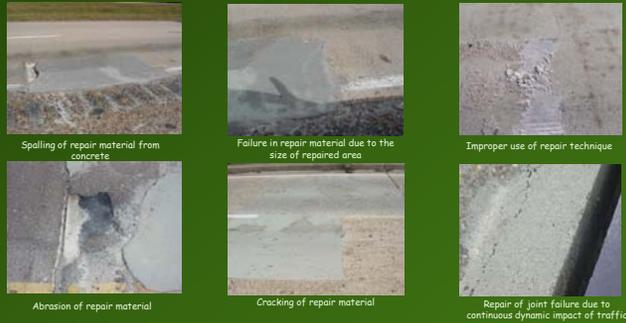
When a composite material (concrete-repair material composite) is subjected to a temperature change, thermal stresses are created due to a mismatch in thermal expansion coefficients (CTE). The difference in the thermal coefficient of expansion between concrete and epoxy formulations can be altered by controlling the amount of aggregate to binder ratio, where filler/epoxy ratio was varied in an attempt to vary (CTE) of repair materials. This considerable difference in coefficient of thermal expansion between epoxies and Portland cement does require careful consideration.

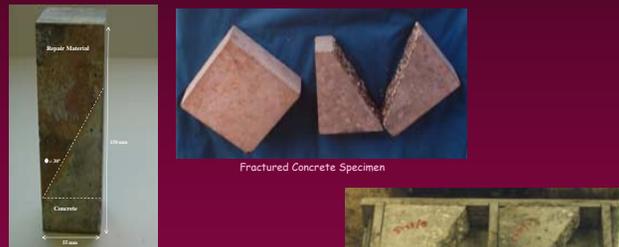
The slant shear test highlighted by B. S. 6319 No. 4 was used to evaluate the bond strength between selected repair materials and parent concrete.
